REAL December 2019 Torque

PALFINGER **PALFINGER** Crane Stow Pin Awareness

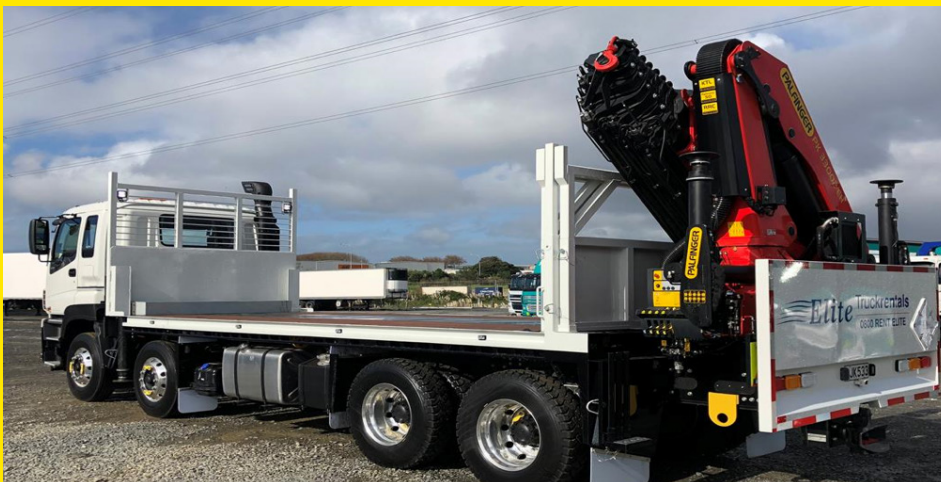
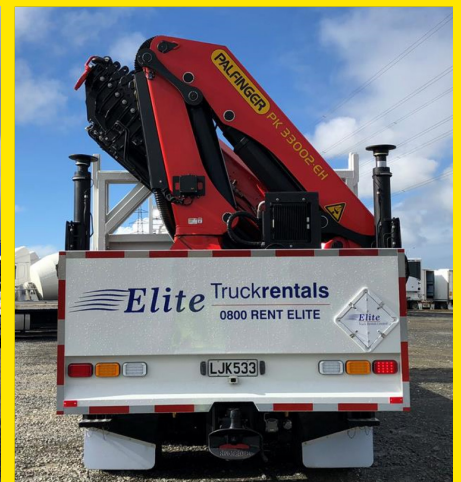
There have been several cases where PALFINGER crane stow pins and support gussets have cracked over time. This is caused by following an incorrect crane stowing procedure. This results in major downtime, with repairs that can take 14 days to 5 months, and repair costs that can range from \$8,000 to \$18,000.

It is important that you follow the correct crane stowage procedure that is unique to the model of crane fitted to the truck. You will find a copy of the crane stowage procedure in the cab of your truck, if fitted with an affected crane

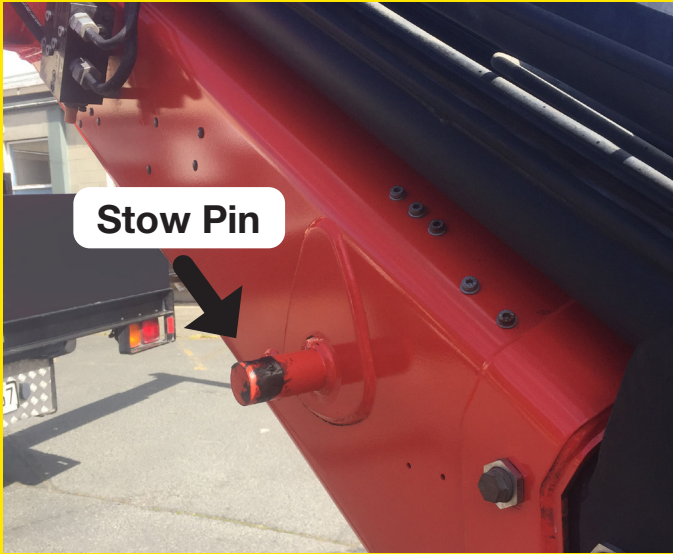
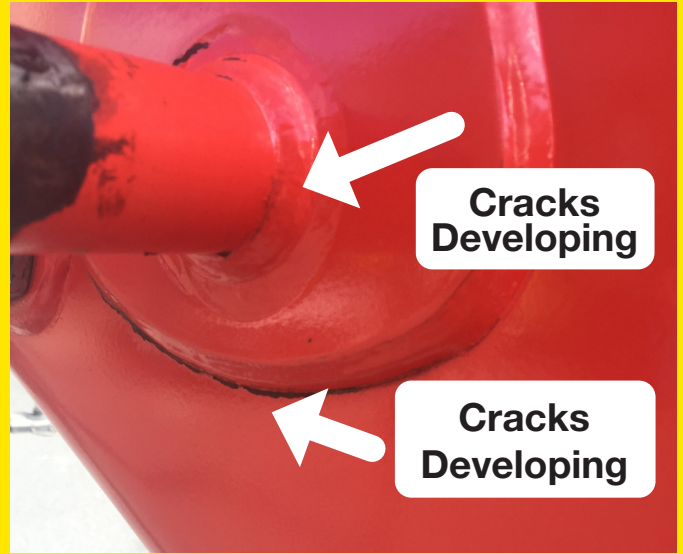
In extreme cases, a complete outer boom must be replaced. The crane cannot be used when cracks are found. A special repair procedure must be carried out which has to be managed by specialist engineers and certifiers. Major parts replacements will generally have to be supplied from Austria which causes additional time delays.

The images below show the damage that can occur on the outer boom if the crane is not stowed correctly.

- ▶ It is highly critical that the correct crane folding and unfolding procedure is followed as this will prevent the above from occurring.
- ▶ TR Group have made a commitment to ensure trucks fitted with affected models of cranes have the correct procedure in the cab.
- ▶ If you can't find a copy of the correct procedure or are unsure, please contact your PALFINGER dealer or their customer support team on 0800 725 346, or contact the TR Group Maintenance Team on 0800 80 80 69.
- ▶ Make sure that you don't 'load up' the stow pin. Instead, try a gentler approach when the crane is being folded or unfolded.
