REAL December 2019 Torque

PALFINGER **PALFINGER** Crane Stow Pin Awareness

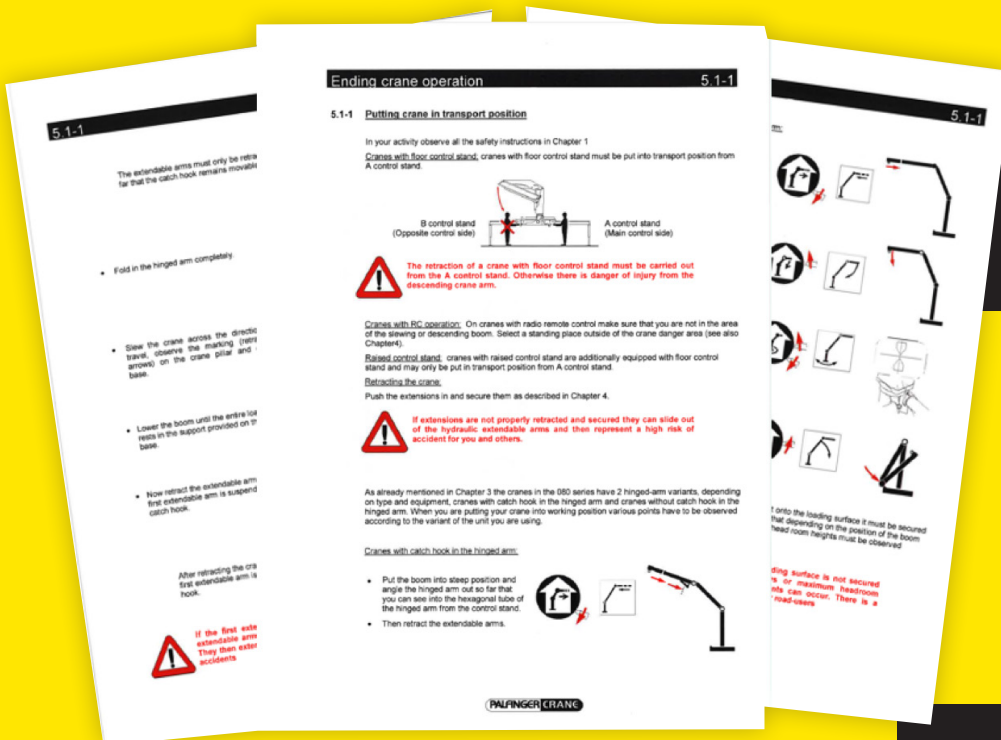
It is important that you follow the correct crane stowage procedure that is unique to the model of crane fitted to the truck. You will find a copy of the crane stowage procedure in the cab of your truck, if fitted with an affected crane

ALWAYS ENSURE YOU REFER TO THE CORRECT STOWAGE PROCEDURE FOR THE MODEL OF CRANE FITTED.
