Torque

Traffic Management Attenuators

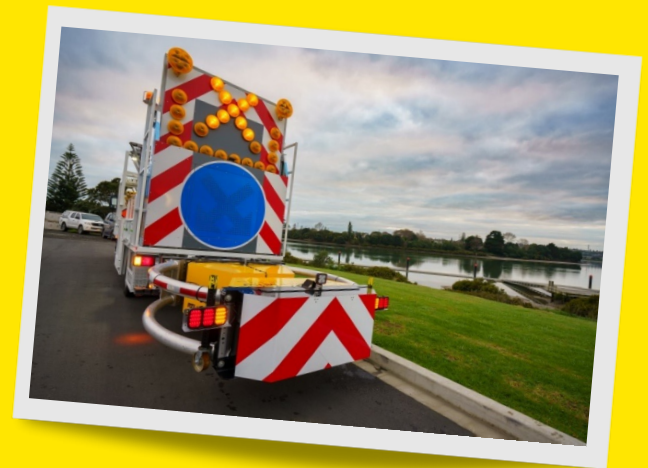
Put simply, an attenuator is an energy absorption device that is designed to cushion the impact of a vehicle crashing into the back of it.

There are several different designs, but the basic concept is that the attenuator has a mechanical component designed to collapse, fold up, or be cut into, in order to absorb the energy.

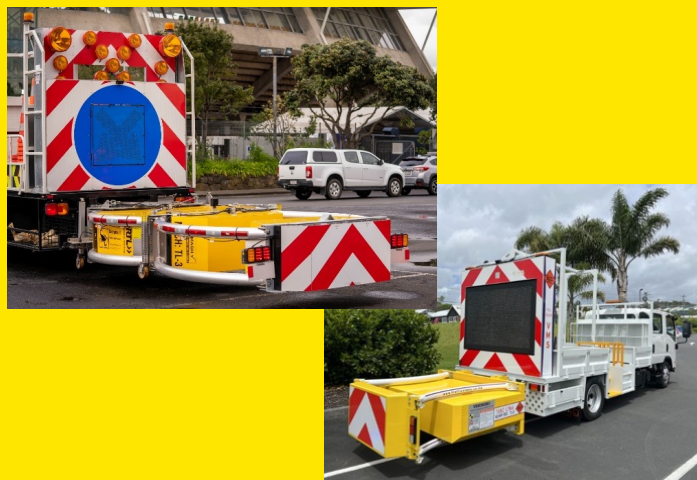
The **Scorpion**, available in TL-2 and TL-3 configurations, has aluminium boxes filled with honeycomb-style absorption material and aluminium tubular hoops mounted on the sides. Together these provide the cushioning action to minimise the impact of the vehicle.

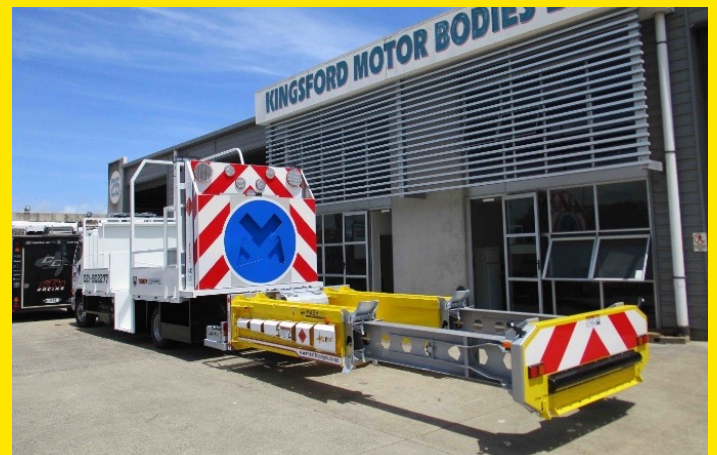
The **Verdegro Blade** is of a different construction and has a set of blades that are designed to cut through the aluminium structure H-beams and collapse as the vehicle crashes into the rear. This particular unit has the ability to go from TL-2 to TL-3 by simply extending out to its full length.

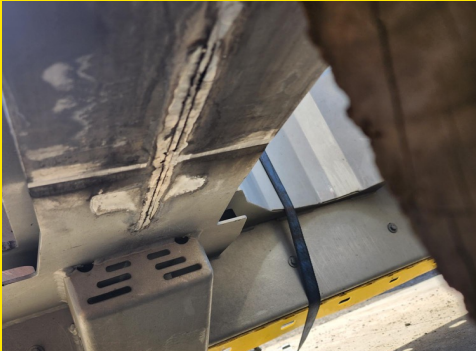
Cracked/damaged H-beam.

- ▶ Damage to outer structure, support rollers, cracking and gear tracks (Blade).
- ▶ Debris inside the H-beams, such as birds' nests, etc (Blade).
- ▶ Sagging or bending of the unit (not sitting at a specified height).
- ▶ Checking if the service history is up to date.

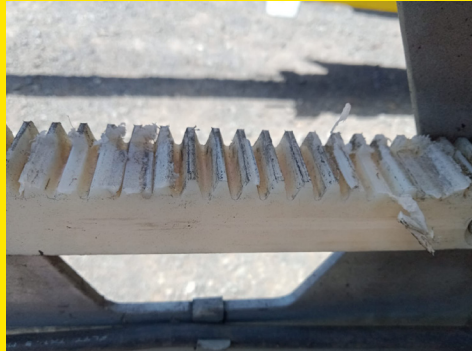
Worn nylon gear track on the H-beam.

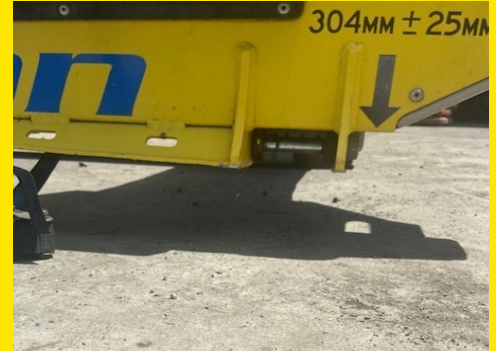
Damaged guide roller due to the unit not being correctly adjusted.

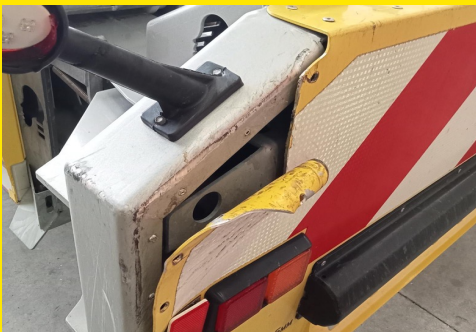
Damage to the rear outer skin.
